Manhole Inspection Summary

Manhole # S25EE2016MH

Insp Date: **11/6/06 2:47 PM**

Location Address: **5700 DROHOMER PL**

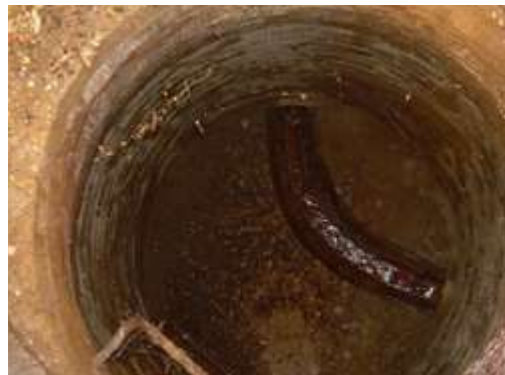
Top View

Corroded steps. Evidence of surcharge - Bench debris.

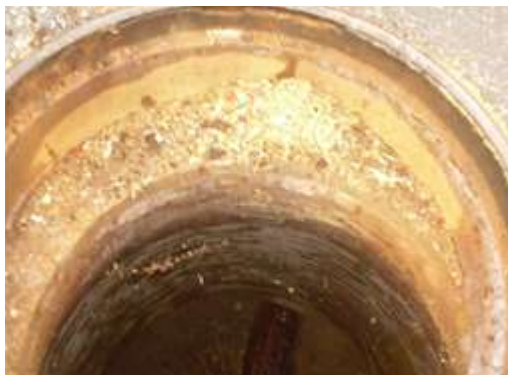
Defect

Frame leaks. Frame offset. Adjustment infiltration.

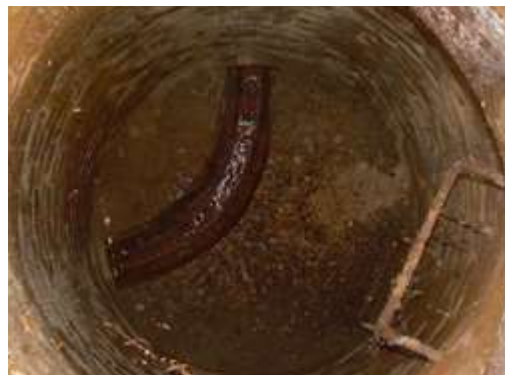
Defect

Adjustment, Corbel, and Barrel infiltration - other side.

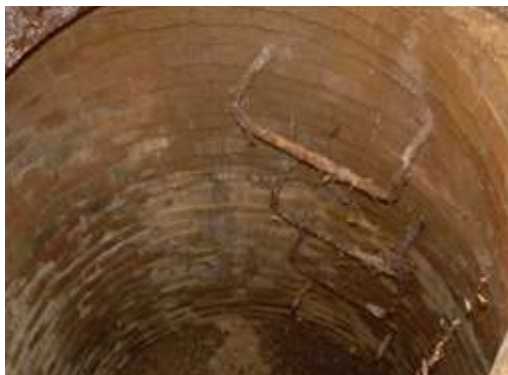
Defect

Adjustment, Corbel, and Barrel infiltration. Corroded steps.

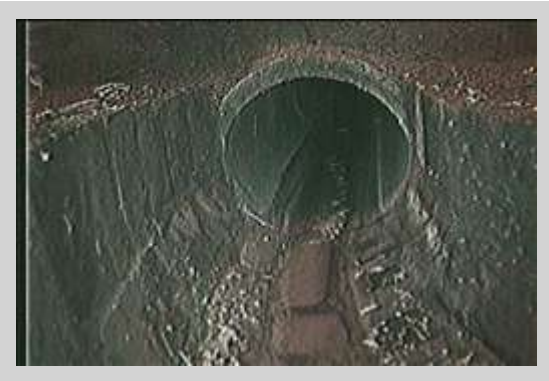
8 in. Circular Gravity Sewer Pipe Out @ 12 O'Clock

Infiltration: **Evidence** Pipe Seal Cond: **Unknown**

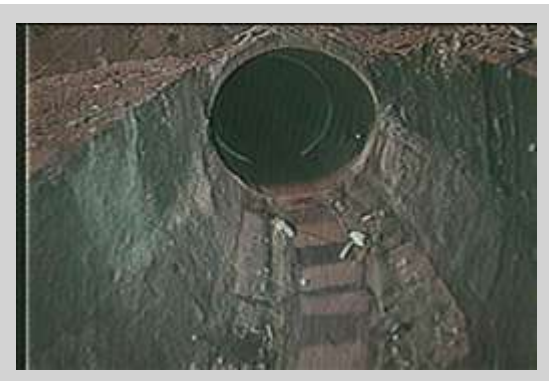
8 in. Circular Gravity Sewer Pipe In @ 4 O'Clock

Infiltration: **Evidence** Pipe Seal Cond: **Unknown**
